Divers Use Sliplining For Underwater Siphon Repairs

WH Streit Inc., Hammonton, NJ, and sister company, Walker Diving Contractors recently completed a major underwater sliplining project to repair two inverted siphons under the Schuylkill River in Philadelphia, PA.

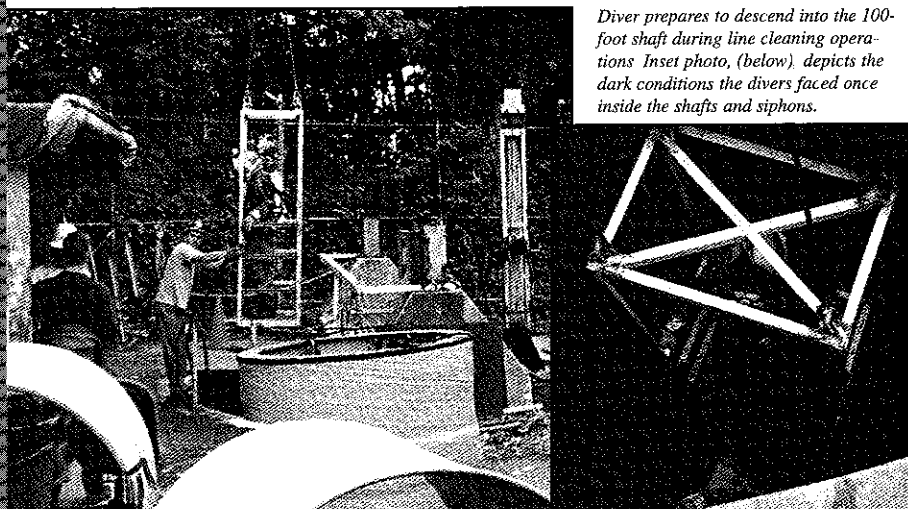
Diver prepares to descend into the 100-foot shaft during line cleaning operations. Inset photo, (below), depicts the dark conditions the divers faced once inside the shafts and siphons.

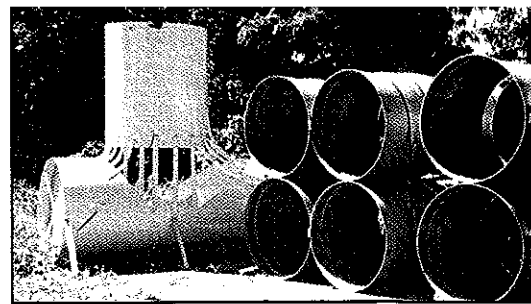
Beele Florida Inc. supplied the 3 5-foot joints of filament wound fiberglass pipe (right) used on the project. The short pipe length allowed divers to rotate the pipe from vertical to horizontal at the bottom of the shaft and then position it inside the 50-inch siphon for final line tie-in

Continuing, Einhorn said the method devised to slipline the siphons called for lowering 3 5-foot pipe joints down through the shaft, rotating them from vertical to horizontal, and then positioning them in precise position inside the siphon for final pipe pull in.
